Post-Analysis of the Potter/Randall Flash Flood Event: July 7-8, 2010

*Maribel Martinez, Ph.D., Assistant Emergency Management Coordinator
Amarillo/Potter/Randall Office of Emergency Management*

Submitted: July 29, 2010

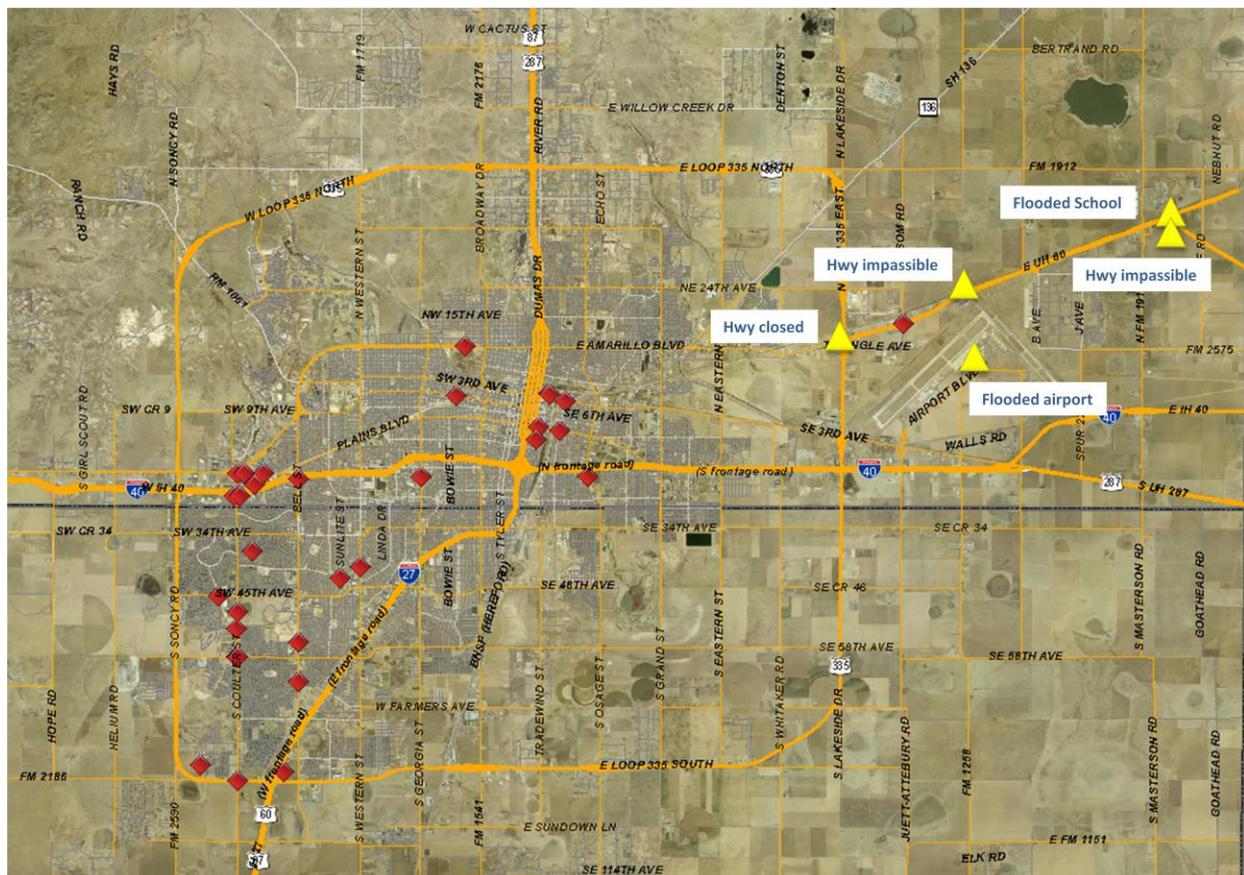
Flash flood reports received by the NWS and Amarillo Emergency Communications Center dispatch data for the evening depict areas within the city and county where flooding overwhelmed roadways, resulting in emergency crews having to respond to stalled vehicles caught in rushing water. A total of 32 swift water rescues took place. In Figure 9, red dots indicate intersections water rescues crews were dispatched to and yellow triangles indicate other reports received. Table 3 lists times and descriptions of the official NWS flash flood reports. Breaking the rescues over hourly and plotting them in conjunction with radar data midpoint timeframe, the roadways with the greatest flooding problems are revealed. Between 11 PM – 12 AM CDT which coincided with the greatest accumulation of rainfall in SW Amarillo, the majority of water rescues (white squares) were in the western portions of the city (Figure 12). As the storm progress westward, flooded roadways extended towards the downtown area and I27 corridor (Figure 13 and Figure 14).

Figure 9: Water rescues and flash flood reports for July 7-8, 2010.

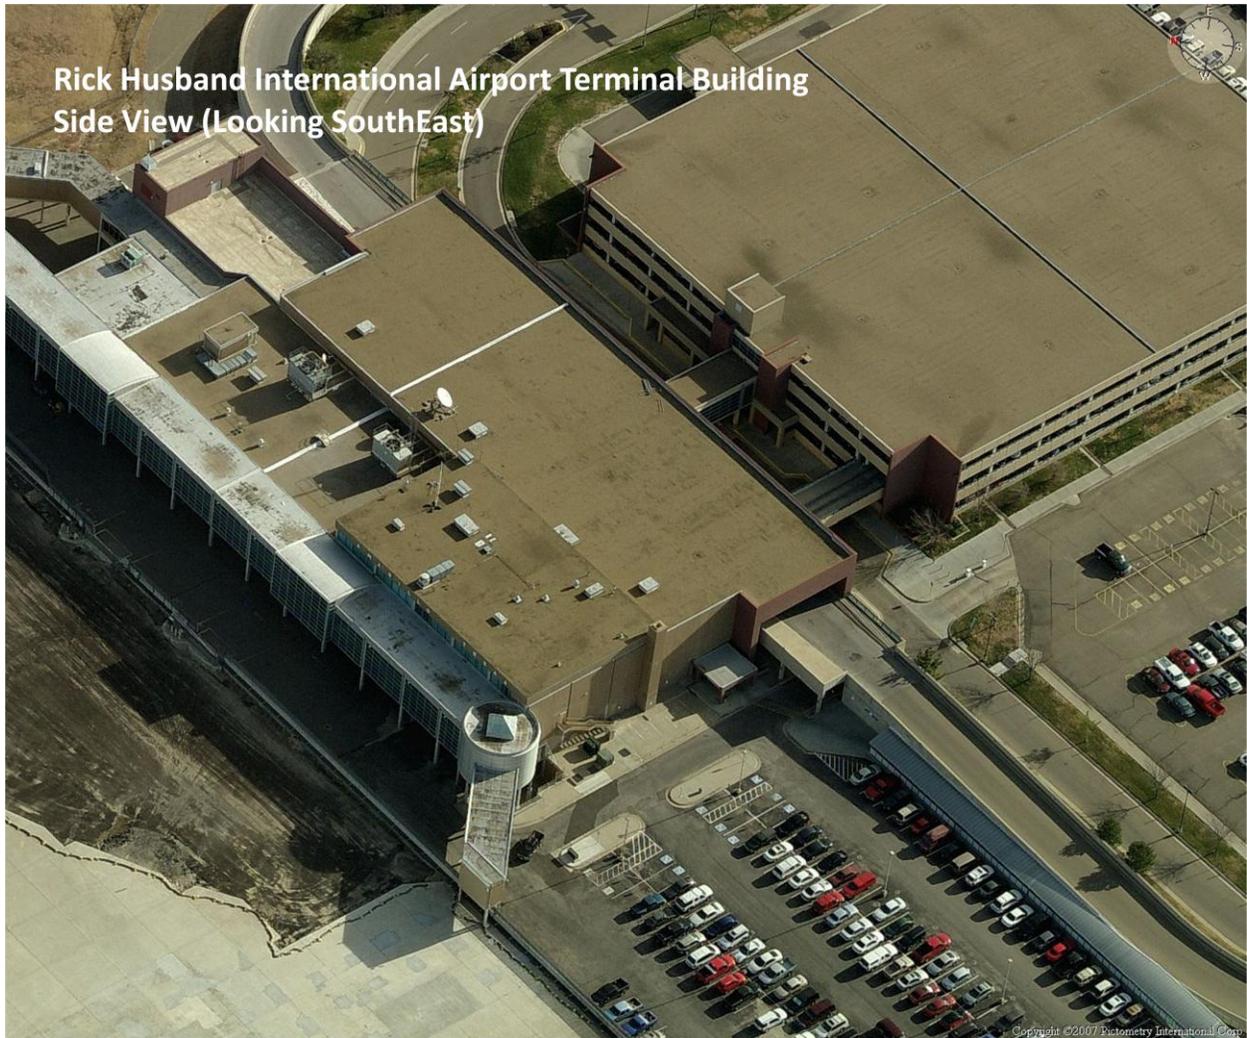
Figure 15 shows an aerial photo of the airport terminal taken in 2007. Additional development and construction is ongoing on the northwestern portion of the facility. To gain perspective, Figure 16 is a side view of the terminal with an open view of what the lower floor of the terminal looks like. As rainfall inundated the area, water flowed into the area behind the baggage claim, down the stairwells, and into the open area in the northwest portion of the terminal, eventually resulting in failure of a wide overhead door and allowing additional accumulating floodwaters into the basement. Pictures in Figure 17 show the water level behind the baggage claim area and the level flood waters rose in the stairwell down to the lower level.

Figure 16: Oblique imagery of the airport terminal looking southeast.

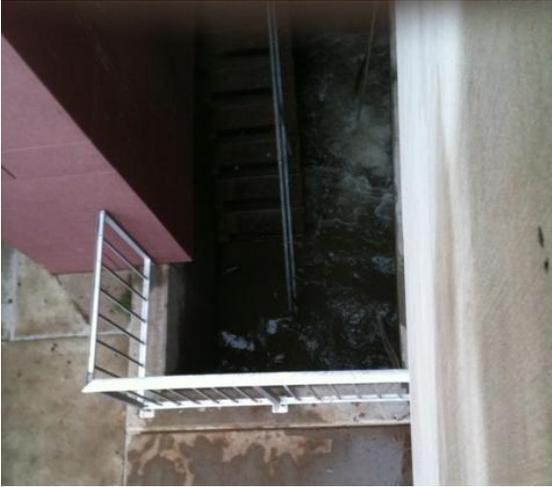
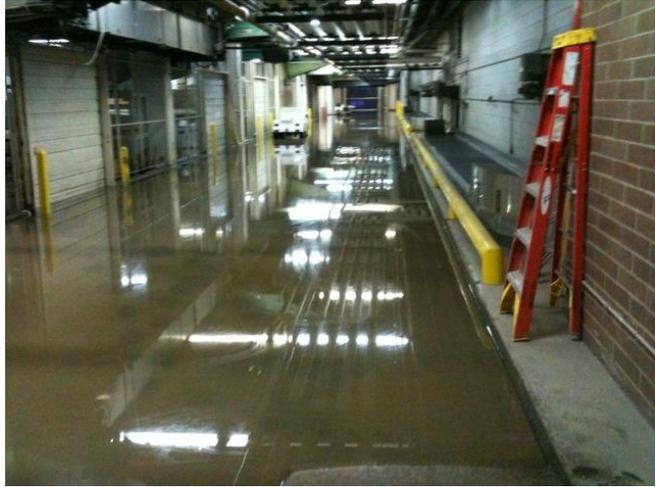
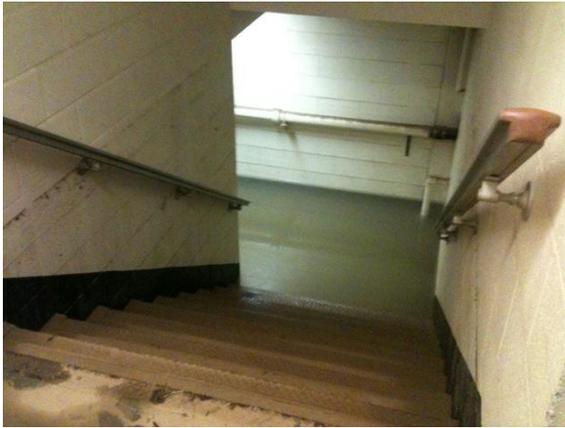
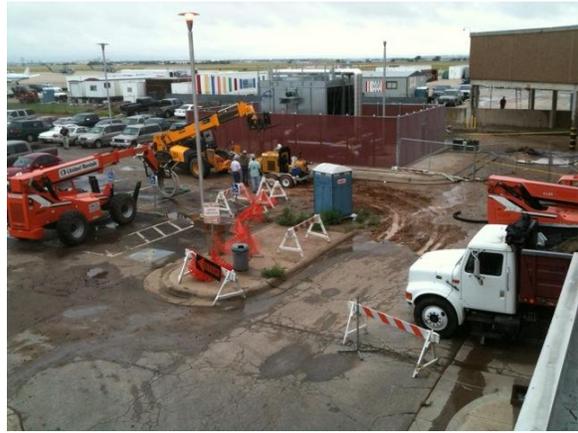
The Rick Husband Amarillo International Airport received 7.33 inches of rainfall in total for the July 7-8 event. The facility's 9,400 square foot basement was completely flooded, inundating land-based phone and internet communications, electrical units, and heating and cooling systems. The airport remained in operation the following day via cell phones, radios, and internet cell cards. By late afternoon on July 8, the majority of the 18-20 feet of floodwater had been drained and pumped, making way for recovery and restoration efforts.

Based on the measurements of the basement, calculations estimate a total of 1,316,320 gallons of water spilled into the basement. Analysis performed by City Engineer Martin Rodin show that this equals to about 189,362 Cubic Feet (CF) of storage. Over a 3-hour duration, it would take about 16 CFS of water flowing into the basement to fill that volume. City of Amarillo Deputy Aviation Director Pat Rhodes reported that by 11:10 PM the airport basement had filled to the top. As seen in Figure 8, rainfall rates at the airport surged from 10 PM – 12 AM going from a total of 0.28 inches to 4.75 inches. A normal 37' city street flowing gutter to gutter during a storm carries about 30 CFS. With water coming in from multiple directions at the airport, the 16 CFS was exceeded during the two to three hour maximum intensity.

Storm mains (blue lines) and inlet locations (green dots) were overlaid on aerial photos of the airport (Figure 18). A total of 5 inlets are located in the back of the terminal and 7 along the front area of the terminal. The storm sewer at the airport was designed in compliance with the Stormwater Management Criteria Manual for a 2-year storm for the Amarillo area (Stormwater Management Criteria Manual, 2010). Due to the magnitude and intensity of the rainfall, the storm sewer was probably at capacity within the first hour of runoff.

Figure 17: Pictures of the basement & behind the baggage claim area (Photos courtesy Daniel Blount).

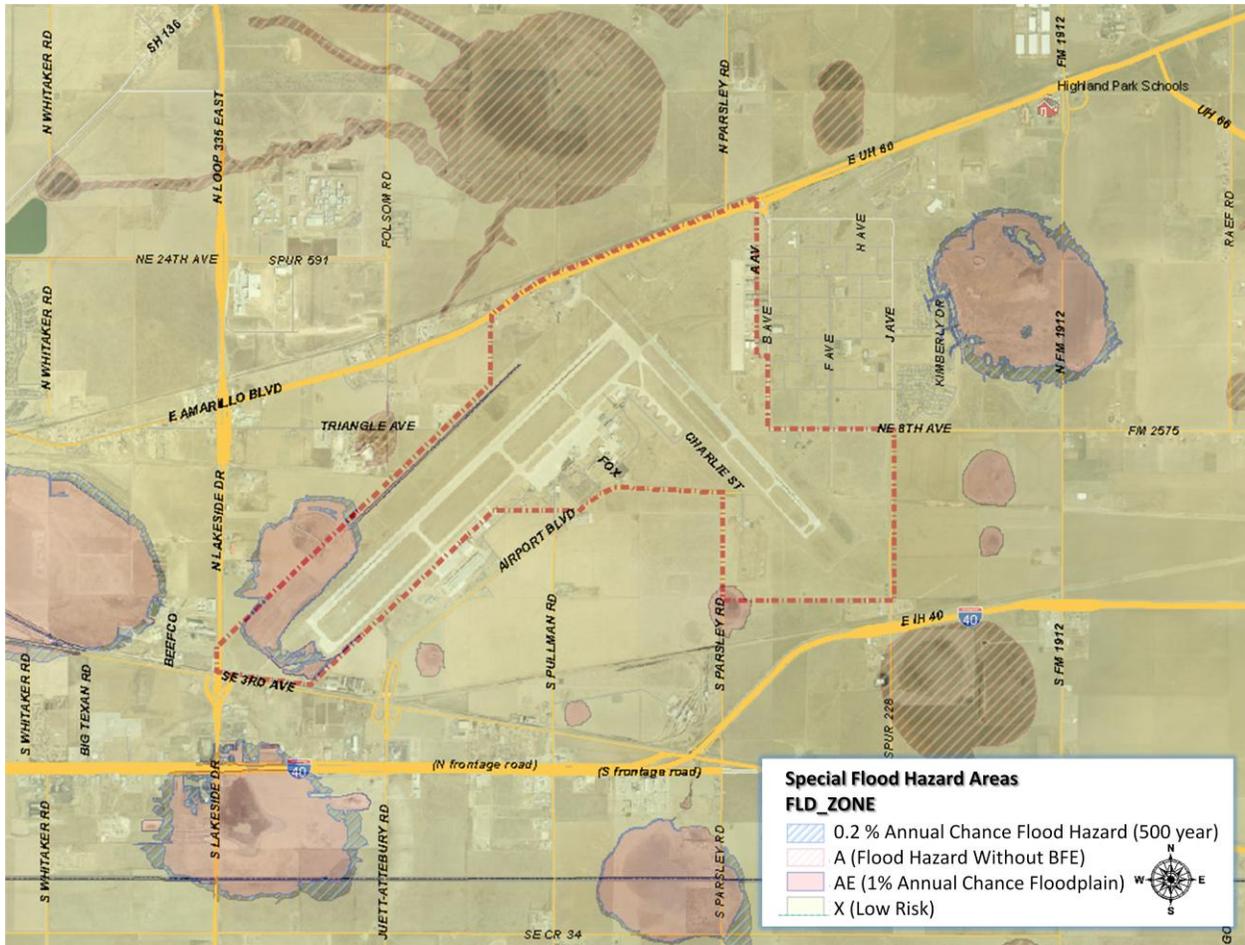
Research into the location of floodplains in the vicinity of airport reveal that the terminal was not located in a floodplain (Figure 19) nor are there any designations of surface ponding (AH). Surface ponding designations are areas subject to inundation by the 1% annual exceedance probability. Elevation data at various points around the terminal (Figure 20) show that terminal is a slightly lower point in relation to the area around it. Water flows from a high point to a low point, so water flowed from the both the rental parking lot and parking lot areas to the lowest point which ended up being the western part of the terminal with the opening to the basement. The flash flood event that occurred was very close to or may have exceeded a 100-year storm since the 24-hour rainfall for a 100-year event according to the Soil Conservation Service for Potter County is 6.5 inches. Mr. Rodin calculated that the

peak runoff (Q) generated by the 100-year storm over the airport drainage area would be 4807 CFS. The volume of runoff calculated would equal a small stream with nowhere to go but straight into the basement at the airport.

Figure 19: Floodplains within the vicinity of the airport.
