Post-Analysis of the Potter/Randall Flash Flood Event: July 7-8, 2010

*Maribel Martinez, Ph.D., Assistant Emergency Management Coordinator
Amarillo/Potter/Randall Office of Emergency Management*

Submitted: July 29, 2010

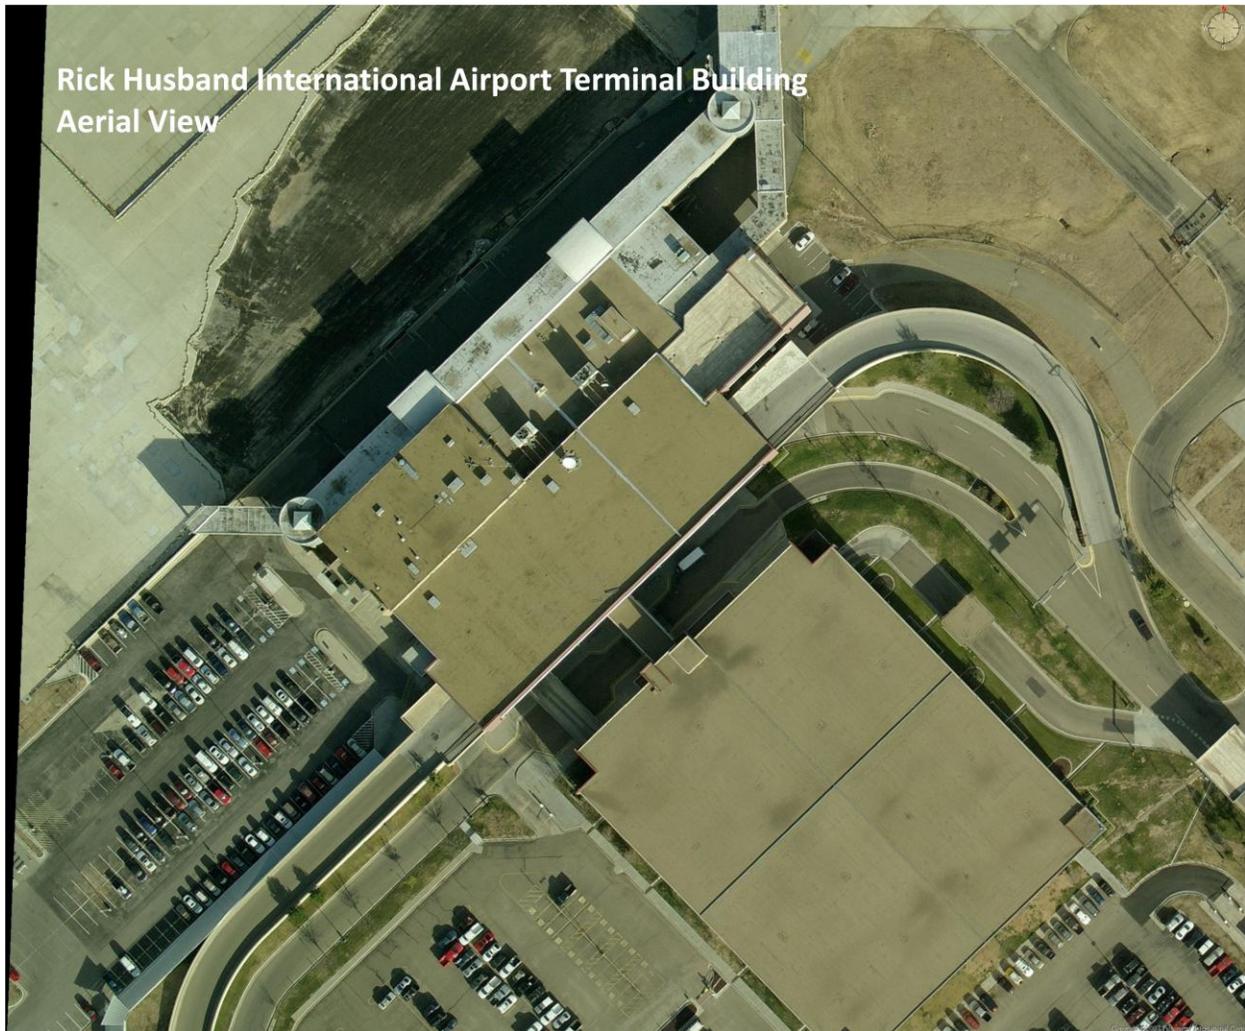
Figure 15: Aerial photo of the airport terminal.

Figure 15 shows an aerial photo of the airport terminal taken in 2007. Additional development and construction is ongoing on the northwestern portion of the facility. To gain perspective, Figure 16 is a side view of the terminal with an open view of what the lower floor of the terminal looks like. As rainfall inundated the area, water flowed into the area behind the baggage claim, down the stairwells, and into the open area in the northwest portion of the terminal, eventually resulting in failure of a wide overhead door and allowing additional accumulating floodwaters into the basement. Pictures in Figure 17 show the water level behind the baggage claim area and the level flood waters rose in the stairwell down to the lower level.

Based on the measurements of the basement, calculations estimate a total of 1,316,320 gallons of water spilled into the basement. Analysis performed by City Engineer Martin Rodin show that this equals to about 189,362 Cubic Feet (CF) of storage. Over a 3-hour duration, it would take about 16 CFS of water flowing into the basement to fill that volume. City of Amarillo Deputy Aviation Director Pat Rhodes reported that by 11:10 PM the airport basement had filled to the top. As seen in Figure 8, rainfall rates at the airport surged from 10 PM – 12 AM going from a total of 0.28 inches to 4.75 inches. A normal 37' city street flowing gutter to gutter during a storm carries about 30 CFS. With water coming in from multiple directions at the airport, the 16 CFS was exceeded during the two to three hour maximum intensity.

Research into the location of floodplains in the vicinity of airport reveal that the terminal was not located in a floodplain (Figure 19) nor are there any designations of surface ponding (AH). Surface ponding designations are areas subject to inundation by the 1% annual exceedance probability. Elevation data at various points around the terminal (Figure 20) show that terminal is a slightly lower point in relation to the area around it. Water flows from a high point to a low point, so water flowed from the both the rental parking lot and parking lot areas to the lowest point which ended up being the western part of the terminal with the opening to the basement. The flash flood event that occurred was very close to or may have exceeded a 100-year storm since the 24-hour rainfall for a 100-year event according to the Soil Conservation Service for Potter County is 6.5 inches. Mr. Rodin calculated that the

peak runoff (Q) generated by the 100-year storm over the airport drainage area would be 4807 CFS. The volume of runoff calculated would equal a small stream with nowhere to go but straight into the basement at the airport.
